### Inspection Report Minerals Regulatory Program June 13, 2013

<b>Mine Name:</b> Daneros	<b>Permit Number:</b> M/037/0126
<b>Operator Name:</b> Energy Fuels Resources	<b>Inspection Date:</b> 6/13/2013
<b>Inspector(s):</b> M. Bradley, W. Western, A. Abate	<b>Time:</b> 10:00a
<b>Other Participants:</b> Ted McDougall, Andrea Reither, Ryan Ellis, plus other EFR personnel	<b>Mine Status:</b> In LMO NOI process

**Purpose of Inspection:** Pre-NOI approval & site familiarization. Site is transitioning from SMO (S/037/0121) to LMO (M/037/0126)

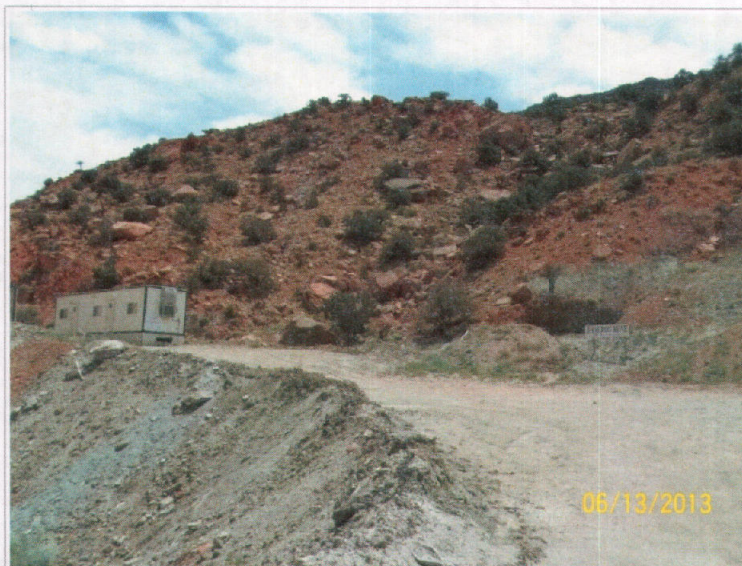
Photo 1 – Main portal area

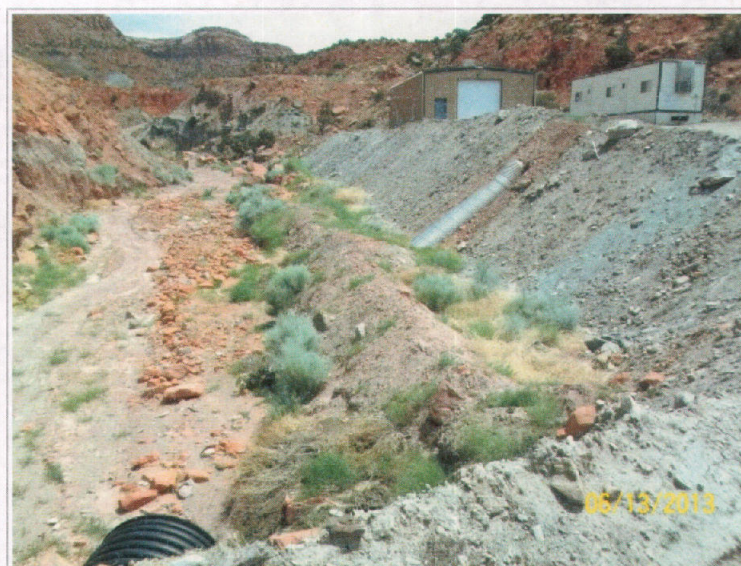
Photo 2 – Main Bullseye Canyon drainage

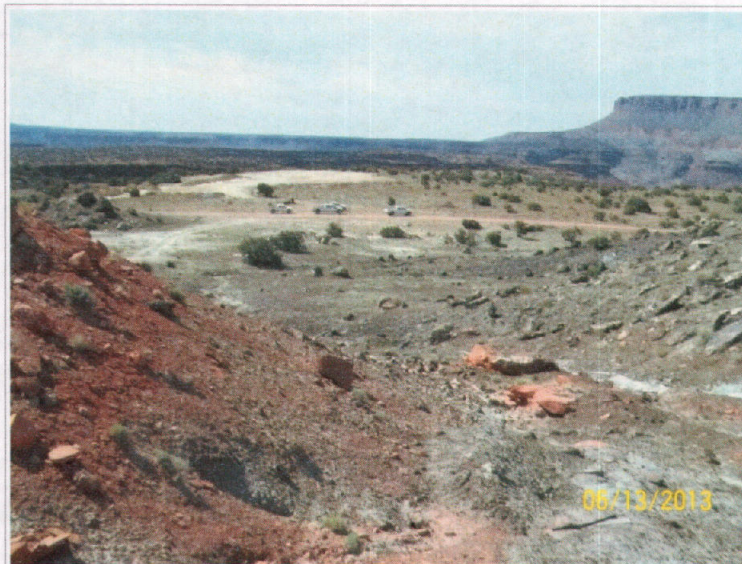
Photo 3 – View toward existing disturbance from South Portal area

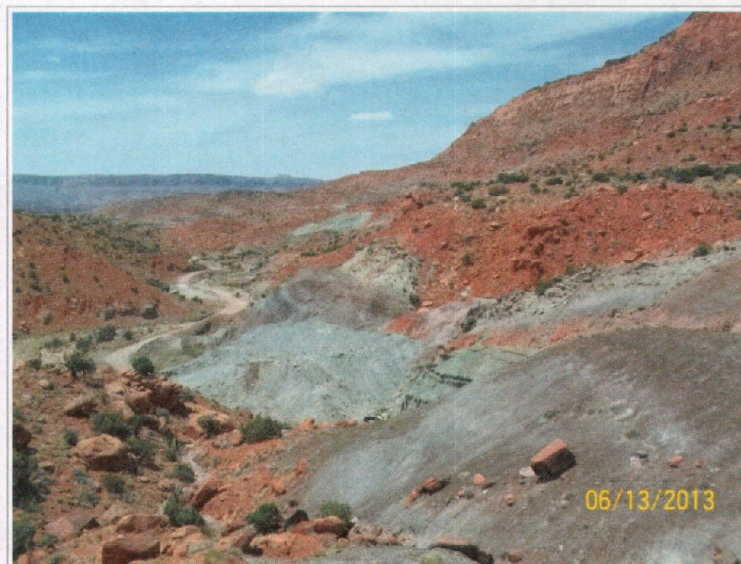
Photo 4 – Existing Development Rock areas from Bullseye Portal

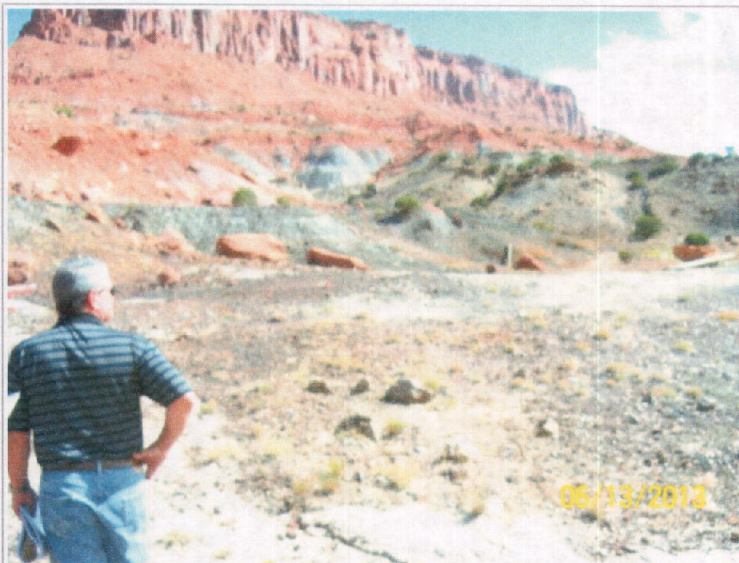
Photo 5 – View toward South Portal area

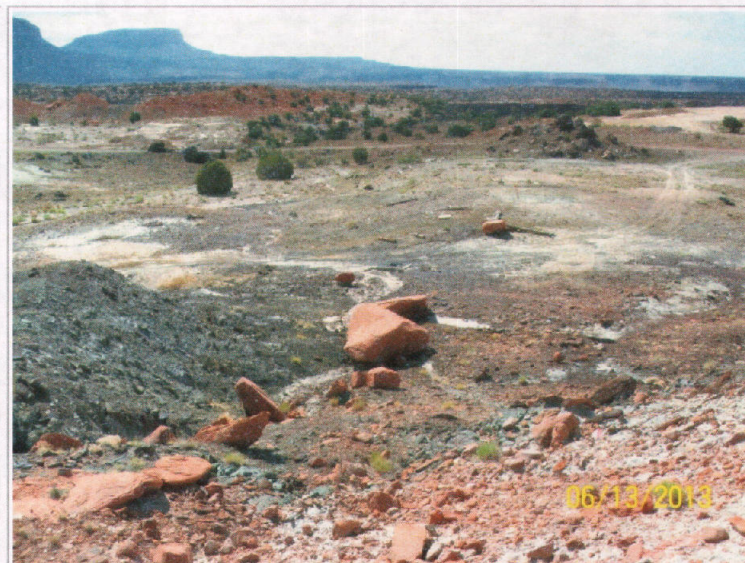
Photo 6 – View from South Portal area

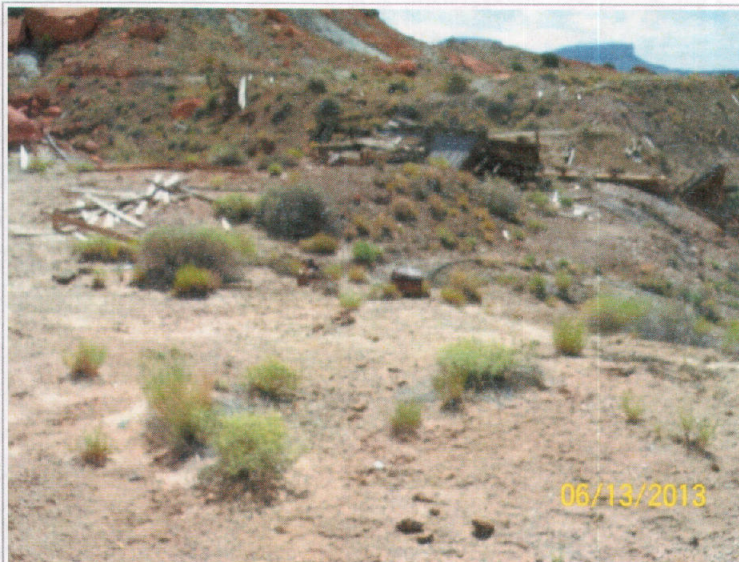
Photo 7 – Existing debris around South Portal area

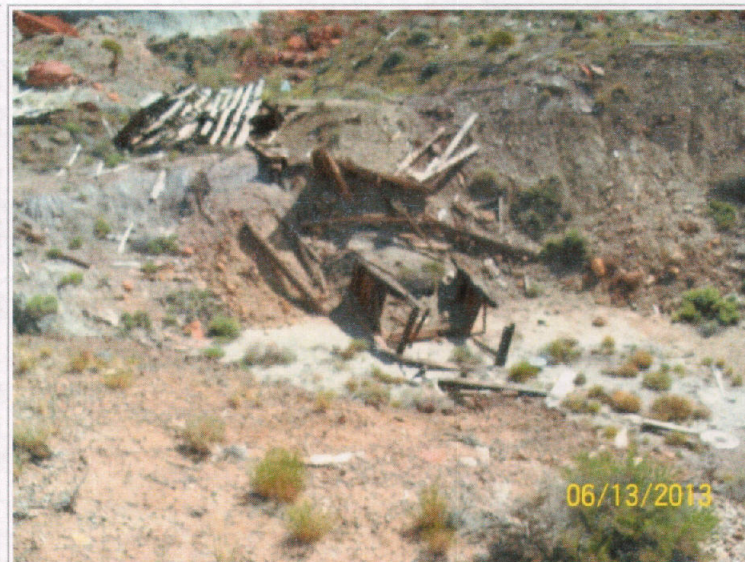
Photo 8 – Collapsed South Portal
